VOLUNTARY RECALL: MAMMUT BARRYVOX 2 AND BARRYVOX S2

RELATES TO THE NEW AVALANCHE TRANSCEIVERS BARRYVOX 2 AND BARRYVOX S2 FROM THE WINTER 24/25 SEASON

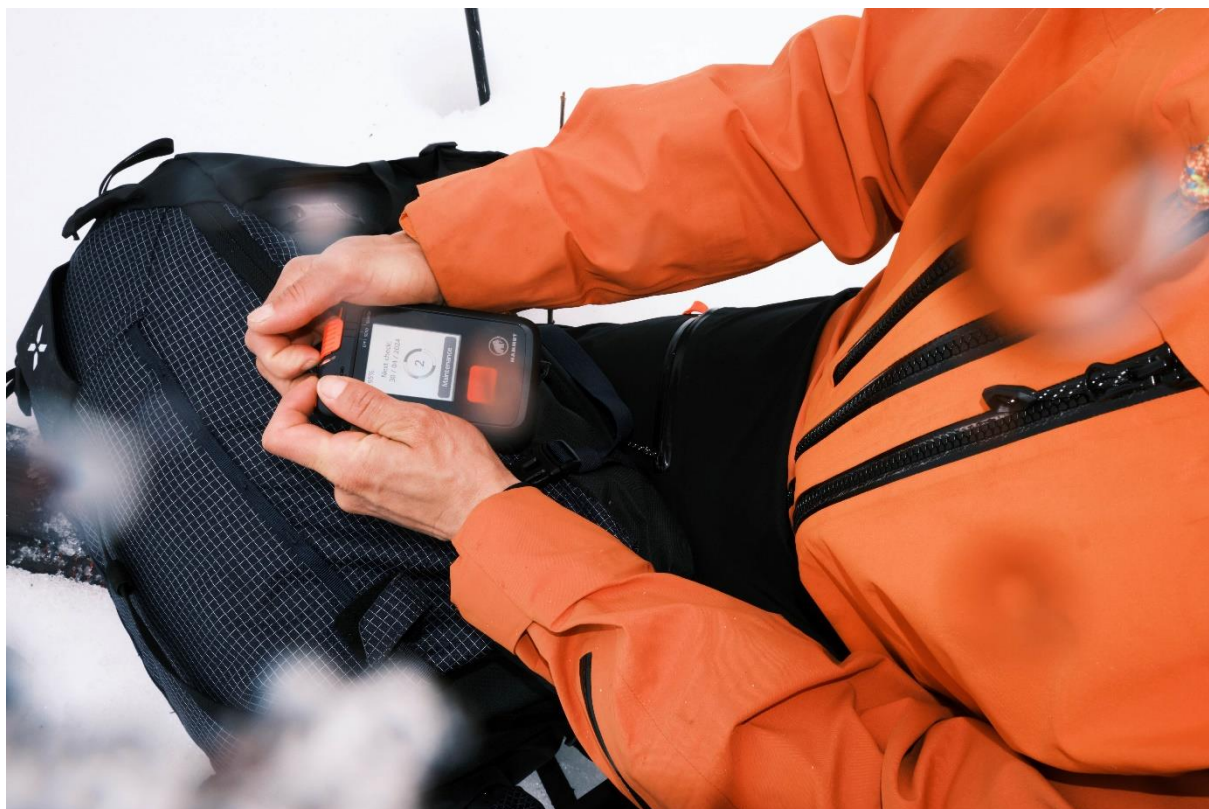
The potential malfunction is based on an assembly issue. As a result, the main switch on the affected devices may be misaligned leading to unintentional switching from Send to Search mode with lateral pressure, or possibly even turning the device off completely. This defect can pose a potential safety risk to users and requires rectification.

Please return your Barryvox 2 or Barryvox S2 for inspection and replacement.

- Check if you own a Mammut Barryvox 2 or Barryvox S2. Please refer to the pictures and style numbers provided for identification of the correct models.
